## THINNING WALL CHARACTERISATION FROM COMBINED MIT MTT DATA

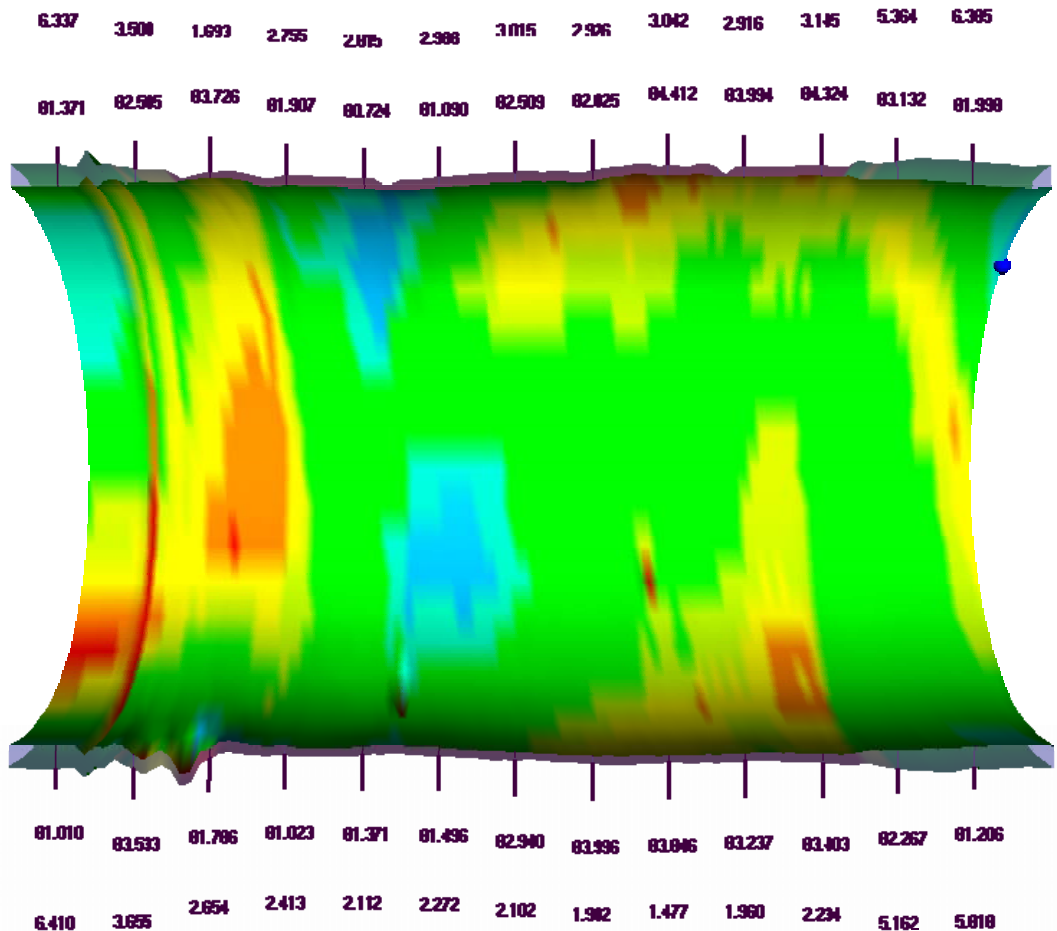
The log data is shown below in a snapshot from Sondex Well Integrity Visual Analysis, WIVA, 3d imaging software. The wall thickness and internal radii values are indicated by the whiskers.
